UNDERWATER FACILITIES  
INSPECTIONS  
&  
ASSESSMENTS

U. S. NAVAL STATION  
GUANTANAMO BAY, CUBA

AUGUST 1980

PERFORMED BY:  
UNDERWATER CONSTRUCTION TEAM ONE

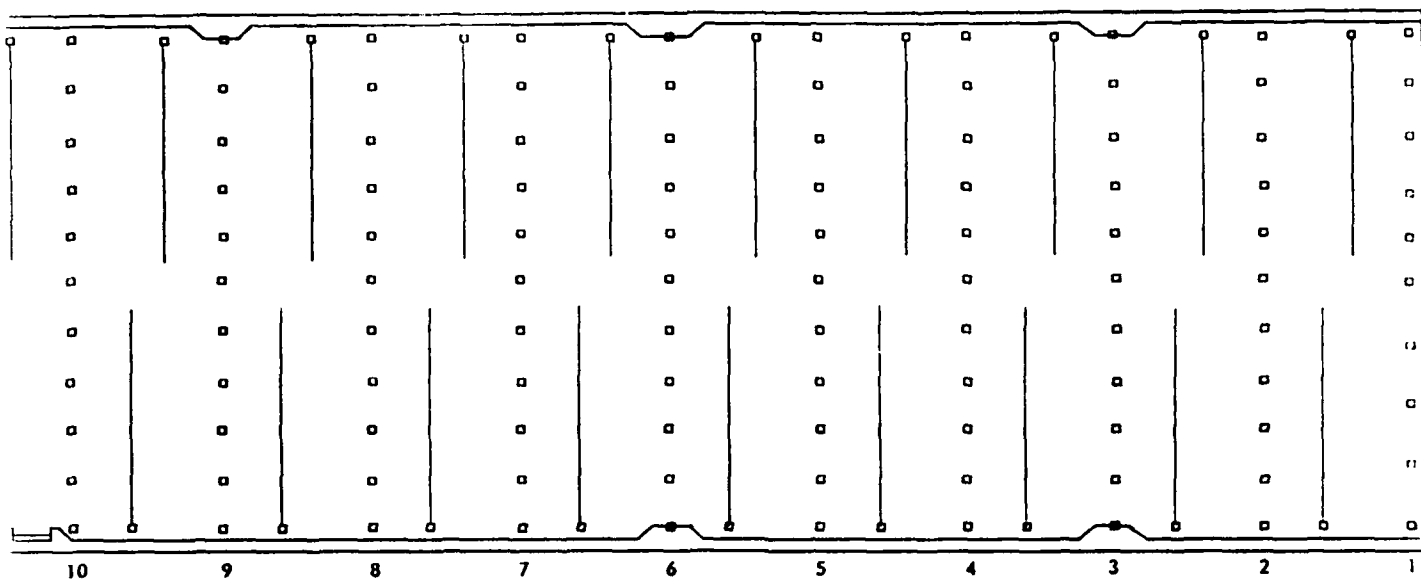
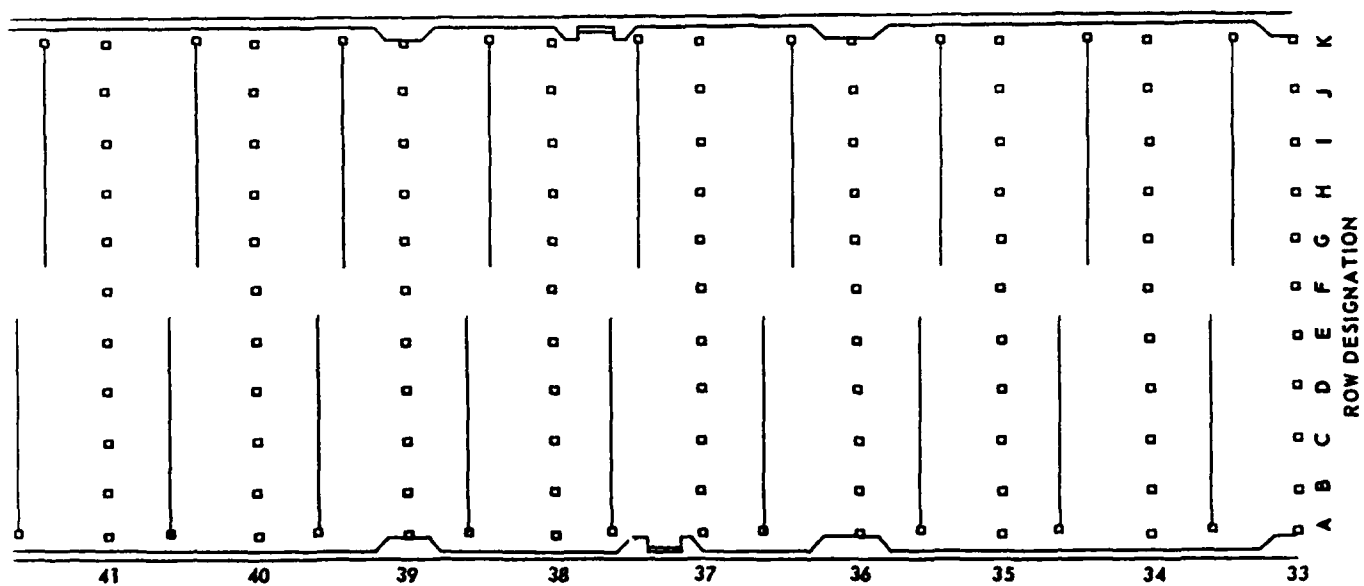
FIGURE 3

Pier V is an open-type reinforced concrete pier that is approximately 1008 feet long and 60 feet wide. The concrete beam and deck structure is supported on precast reinforced concrete piles arranged in sixty-four bents with eleven bearing piles and one batter pile per bent as shown in Figure 3. Also illustrated in Figure 3 is the pile designation system used in the following illustrations and tables.

PIER V (VICTOR) - US NAVAL STATION - GUANTANAMO BAY  
INSPECTION PLAN

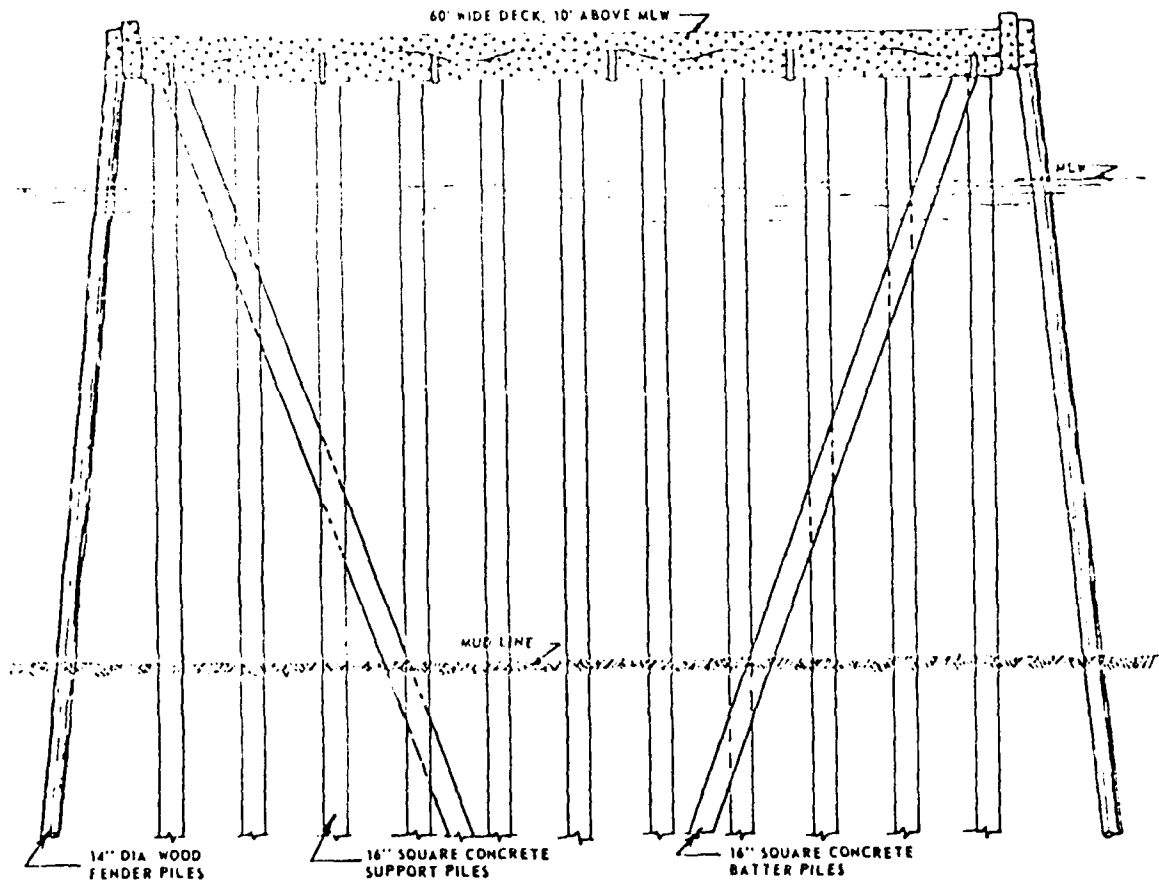
FIGURE 13A

The underwater inspection revealed that the concrete was spalling from most of the structural members, and that the reinforcing bars were exposed. Typical examples of the concrete deterioration underwater are shown in the following:

The location of some of these damaged areas can be envisioned by reference to Figure 13A which is a cross section of Pier V.

CROSS SECTION OF PIER VICTOR

The practice of securing the fender system directly to the bearing piles will cause early deterioration of the concrete piles. The future utilization of Pier Victor depends upon the rate of progressive deterioration of

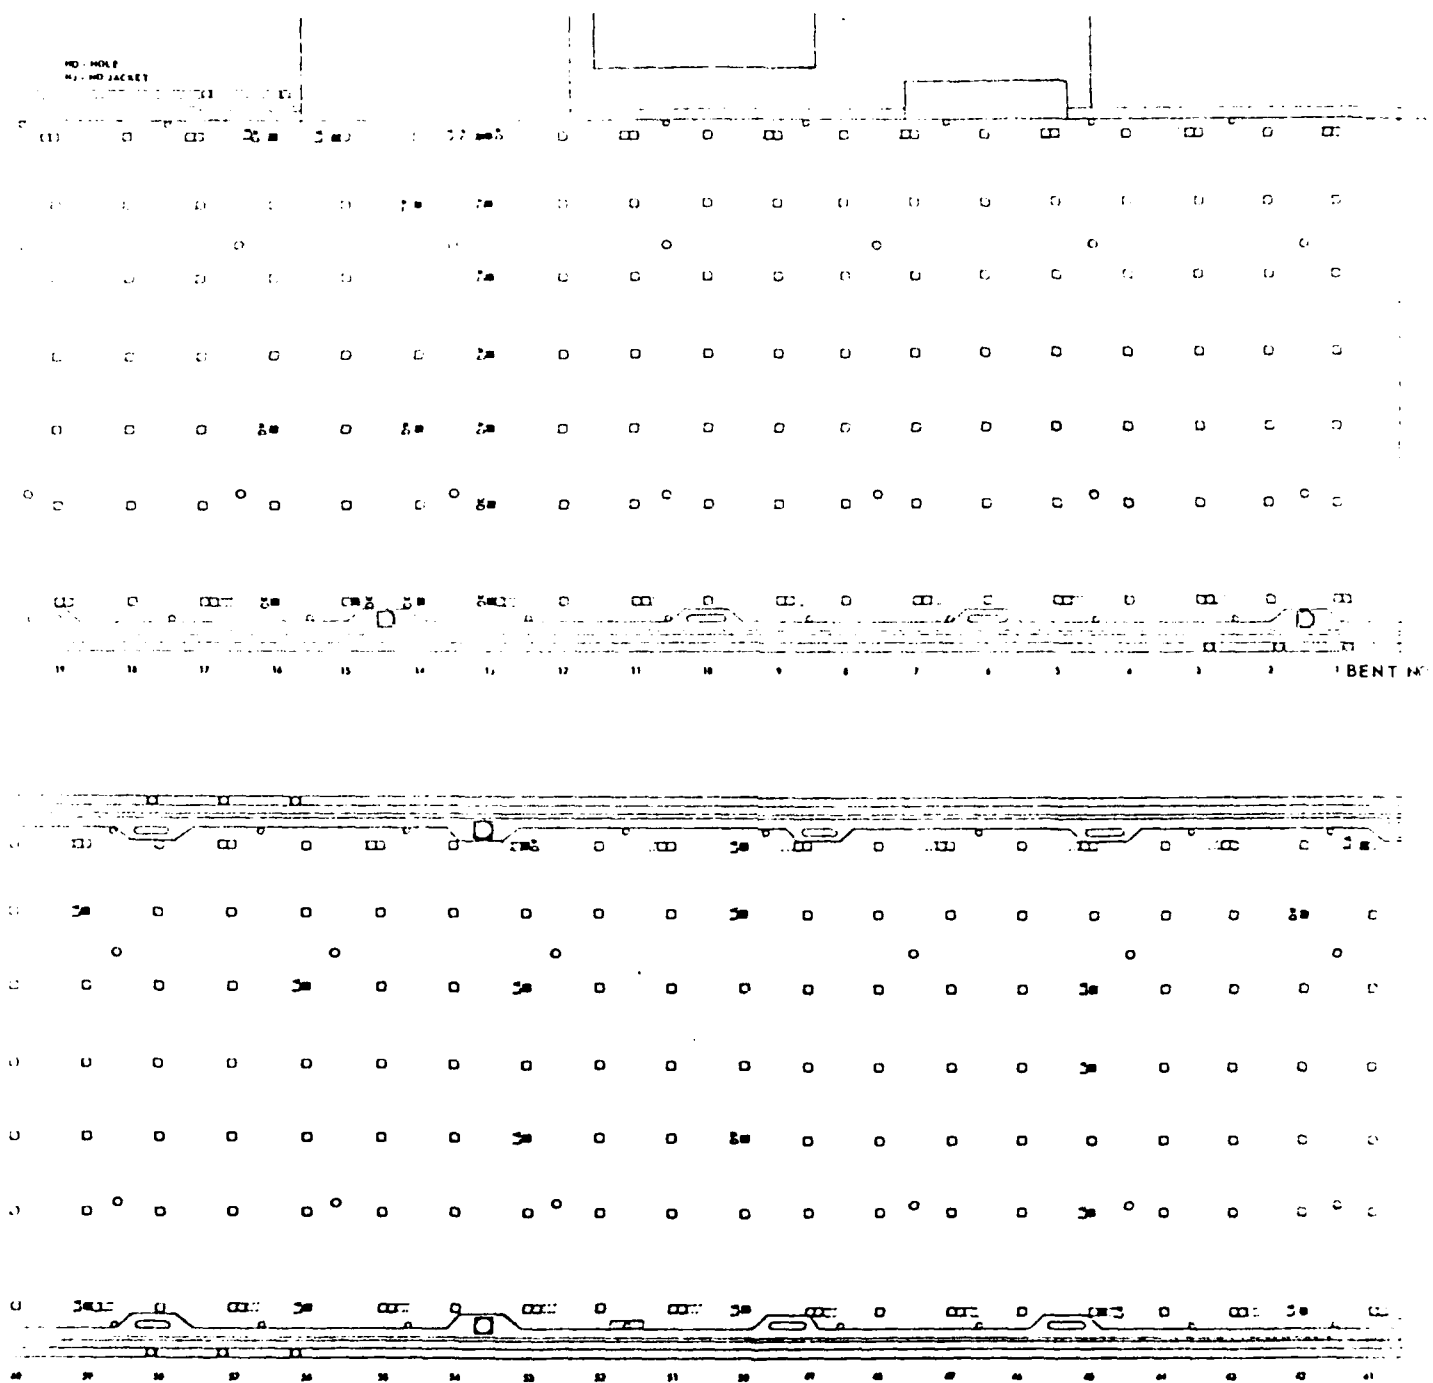
FIGURE 14

- o accelerating the corrosion process of the H-pile;
  - o providing limited or no protection to the H-pile;
  - o missing entirely.
- d. The steel H-piles that were inspected are severely deteriorated by a process resulting in layered corrosion (Figures 15-17). The laminations appear to be a form of iron oxide that develops on the steel and progressively forms subsequent layers as pits form in the oxide coating and let moisture into the interface. These oxide coatings either remain intact or are removed by the impact of debris, the wave action, or the excessive accumulation of corrosion products between oxide layers.

PIER L (LIMA) - US NAVAL STATION - GUANTANAMO BAY  
INSPECTION PLAN

Additional designations of damage or deterioration are given both in Figure 14 and in Table L1.

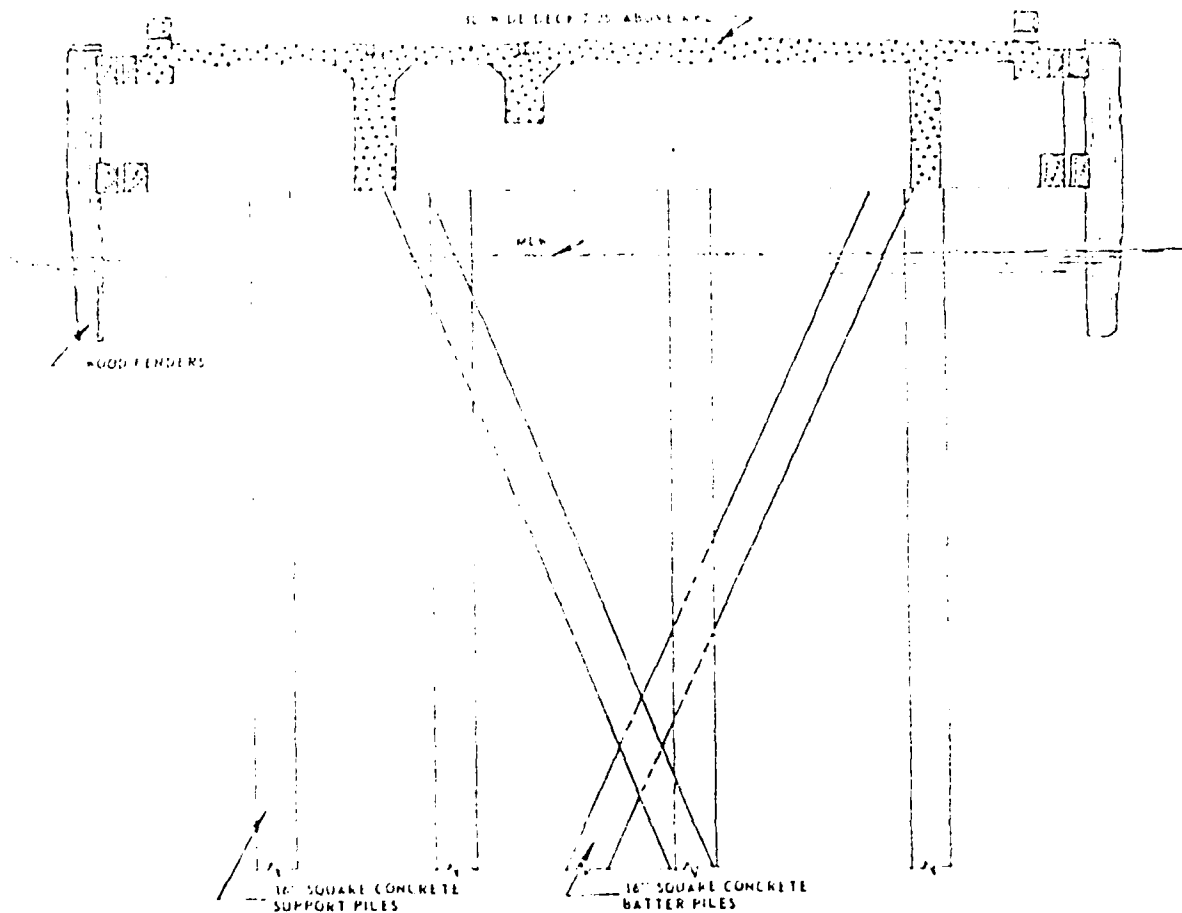
FIGURE 24A

- o Figure 19: Exposed reinforcing bar of pile caps and stringers.
- o Figure 20: Destroyed fender system.
- o Figure 21: Fungus rot of fender pile top and anodic degradation of cleat.
- o Figure 22: Destructive camel system.
- o Figure 23: Deteriorated repair of pile top and stringer.
- o Figure 24: Limnoria attack and fungus rot of dolphin piles.

Areas of deterioration can be determined by reference to Figure 24A.

CROSS SECTION OF PIER DELTA

Future utilization of Pier D will depend upon the rate of progressive deterioration of the pier structure. It is recommended that:

- o Repairs to the deteriorated concrete be initiated, as soon as possible.

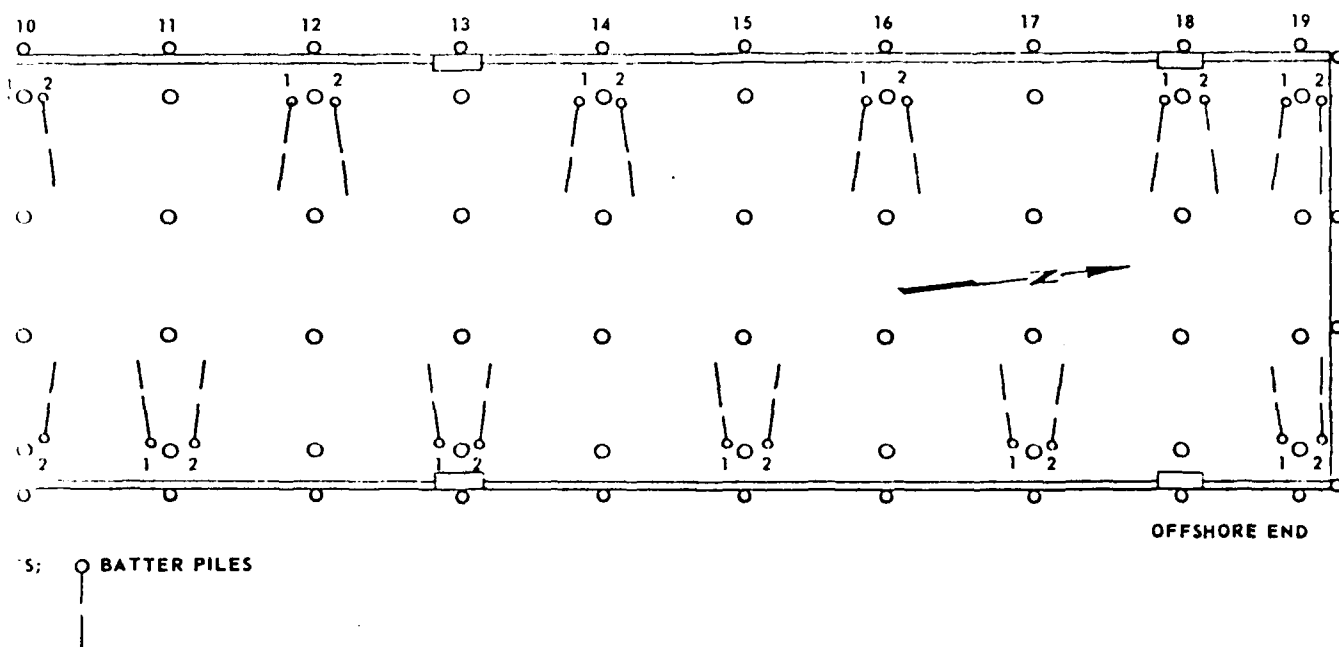
FIGURE 25

PIER Q (QUEBEC) - U. S. NAVAL STATION - GUANTANAMO BAY  
INSPECTION PLAN

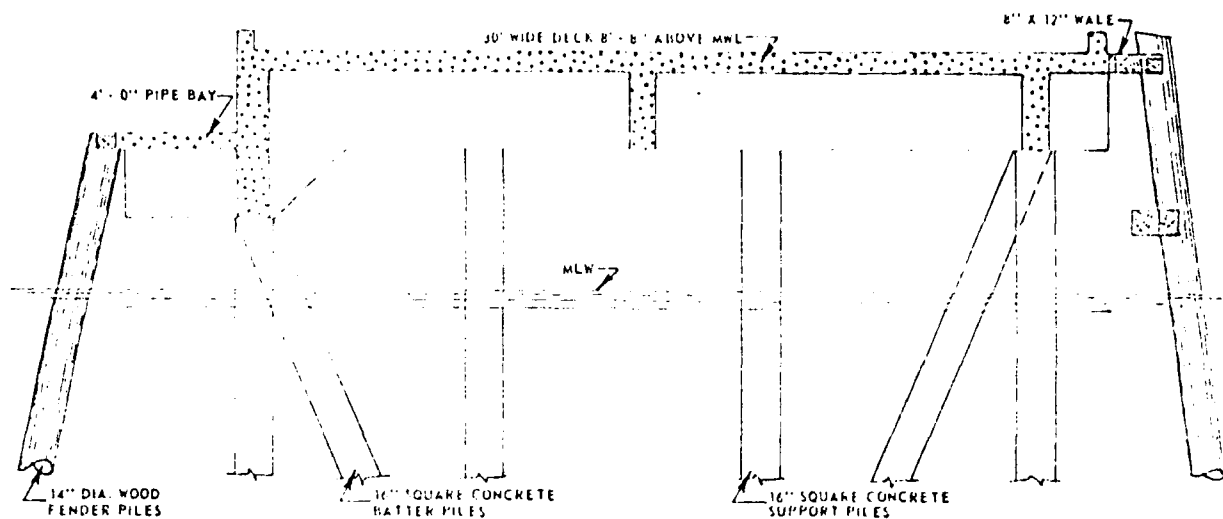
FIGURE 33A

- o Figure 31: Deterioration of top portions of sheet piling and soil subsidence.
- o Figure 32: Spalling of concrete at fender tie-rod connection.
- o Figure 33: Spalling concrete cover of fender piles.

These areas of deterioration may be identified by reference to the pier cross-section shown in Figure 33A.

CROSS SECTION OF PIER CHARLIE

Future utilization of Pier C will depend on the effective repair of the deteriorated portions of the structural portions of the pier. It is recommended that:
